301 Lincoln Avenue - Hilliard Cottage - Penny Pagano and Philip Potter
Year Built: 1876

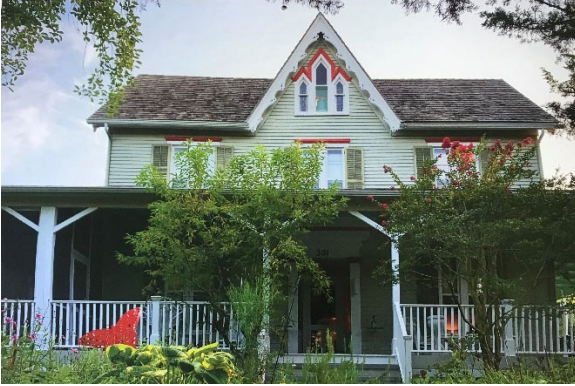
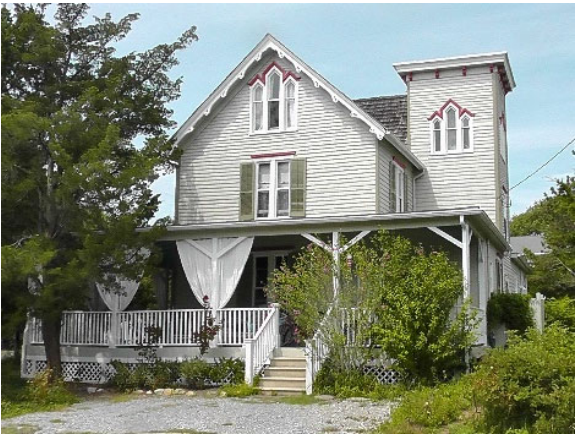
Recent photos

- The existing porches were in need of repair. When the house was moved in 1936 due to erosion, it appears one of the three porches fell off. Replacing that original porch and repairing the existing porches required special carpentry and significant structural supports due to new piling requirements, which far exceeded those of the original pilings. This is not standard construction work and takes experienced and patient craftsmen with special skills and experience.

- The three-story tower on the back of the house with a widow's walk is a unique feature of the house and needs to be regularly maintained to control leaks and prevent damage to the ceiling and walls underneath. Damage to the deck and walls from constant sunlight and rain also require periodic repair and replacement.

- The original pilings that support the whole house were not sunk as deeply in the sand as pilings are today, and they have a tendency to sink over time. The entire rear corner fell off its pilings at one point, causing cracks in the plaster on all three floors. Cracks in old plaster/lathing walls and ceilings need repair due to movement of the house during storms or settling of the original shallow pilings and supports for the house.

- Repair of the original single paned windows are challenging because they are tall and narrow and cannot be easily replaced. Any repair needs to be done by a carpenter by hand, as does the woodwork surrounding the windows.

- The exterior is made from old cedar lap siding which requires painting and repair to maintain. There is constant wear to the exterior of the house due to the weather and the house requires repainting at considerable expense every 8-10 years. Areas of the house where the weathering is most severe require more frequent repainting.

- The new porch was added in 2007. It was rebuilt front to back on new pilings with significant structural supports that now also support the porch side of the house. New code regulations required installation of a large heavy beam to support the porch roof and structure. This also required special work to integrate the new porch with the old. Special beams were handmade and installed, ultimately requiring replacement of the kitchen roof to make it all fit. The new porch was fully screened in and tall French doors replaced the windows in the dining room, opening this side of the house to the outdoors for dining and relaxing. A door to the kitchen was also added. The design of the new porch followed as closely as possible the original design of the porches and was integrated into the front porch. Railings were added to the porches at this time to reconstruct as closely as possible railing seen in old photos.

- Significant repair and replacement of the deck and interior walls of the widow's walk was initiated. The old and damaged wood inside the walk was removed and replaced with treated and heavily sealed lumber to protect it somewhat from the elements. It is regularly maintained. The original cedar lap siding on the exterior is also regularly repaired and painted to keep the appearance and structure of the original design.

- The sinking pilings were shored up or replaced with concrete piers. Cracks were repaired and the plaster repaired or replaced on lathing where possible. All plaster walls were preserved when possible, but when the damage was too extensive drywall panels were used to replace the plaster. To date the walls and ceilings on the first and second floors have been repaired and repainted. The third floor awaits this repair.

- The windows and frames are repaired as needed by a carpenter. The original glass panes in the windows are protected to preserve all the imperfections of the old glass. The original sash windows use rope, pulleys and weights to raise and lower them. The ropes wear and break at times and are replaced.

- High quality paint is used to withstand the elements at The Point. Some sections require more frequent repainting than others. Although vinyl or other artificial siding would reduce painting costs, maintaining the old cedar siding keeps the integrity of the original house. Paint colors are modified from time to time, varying slightly from the traditional Quaker Gray and white. The house is currently a gray/sage with dark sage trim and white and red accents to bring out the house's special design features.
